Case Study – First Floor Kitchen in an Established Building Complex

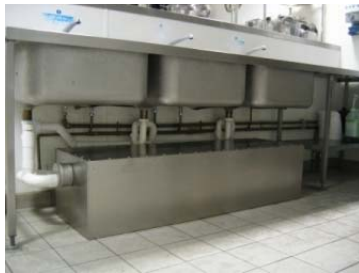
An unusual triple bowl potwash is serviced by a specially fabricated stainless steel unit which has been designed to provide maximum grease control while utilising the available space.

The triple bowl potwash sink

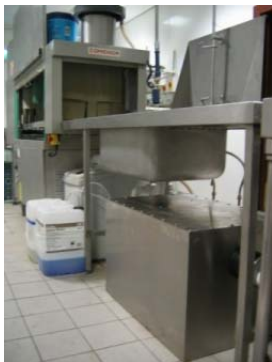
The pre-wash single bowl potwash and pass through dishwasher are serviced by two smaller stainless steel units.

Potwash Unit

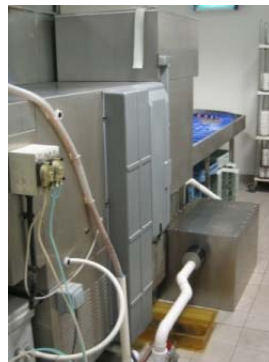
Dishwasher unit
